# ROCK PRODUCTS®

# Magnetic Magic

Magnesita Refractories Solves its Tramp Metal Problem.

By Mark S. Kuhar

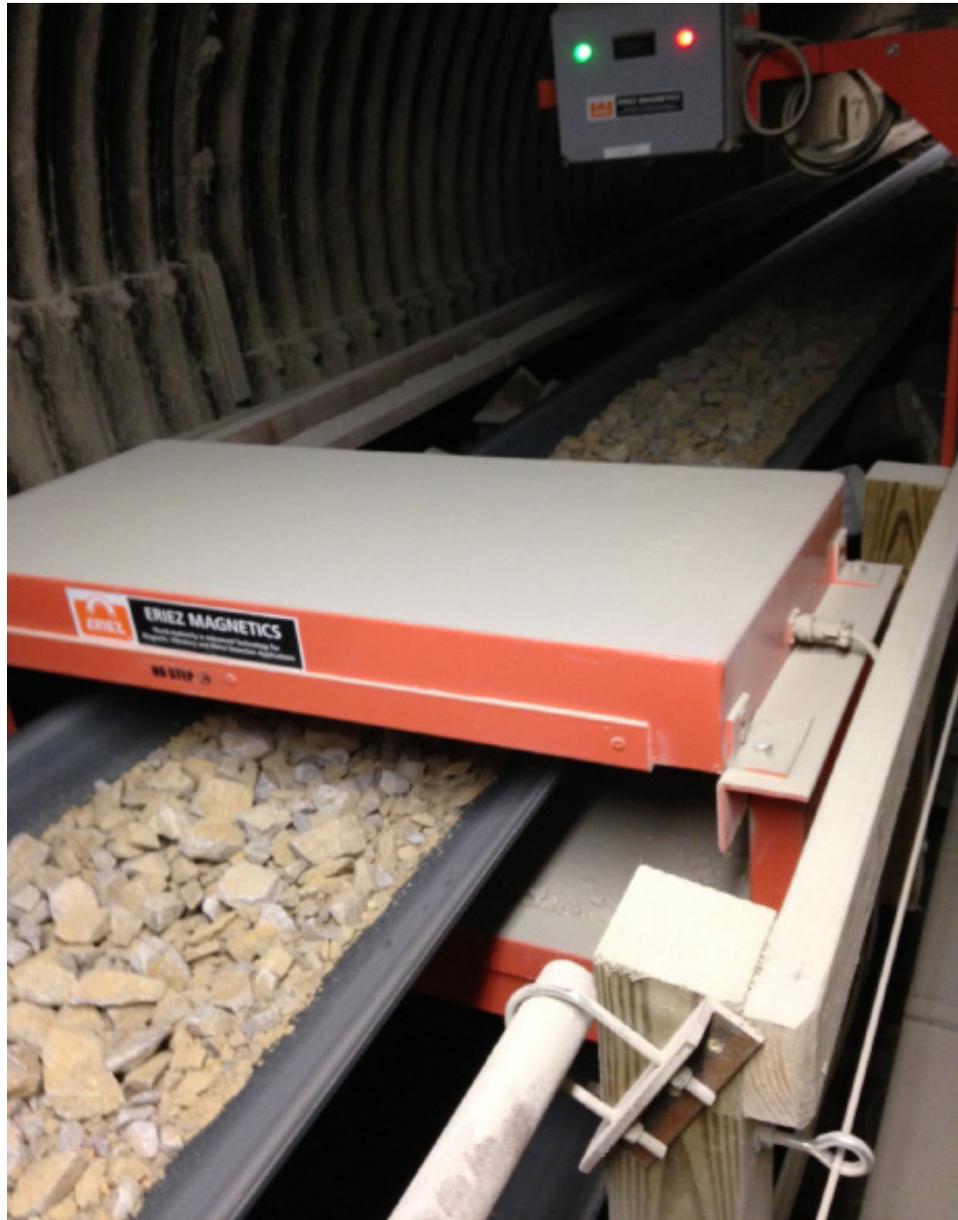
Once officials at Magnesita were satisfied with the metal detector, the next phase was based on another Eriez recommendation, which involved the company’s Model SE-7520 Self-Cleaning Suspended Electromagnet. The unit is located above ground on the 36-in. wide Q7 conveyor belt, about 100 yd. from the metal detector, according to Dixon. The Eriez electromagnetic unit was installed in October 2014.

Magnesita was using an older manual cleaning style, permanent suspended magnet. The newer Eriez electromagnetic unit operates at a much higher efficiency. This self-cleaning electromagnet has field strength 2.5 times stronger than the older permanent magnet at the same cross-belt 10-in. suspension height.

our previous unit,” Dixon said. “The self-cleaning function has eliminated man hours to physically clean the magnet and the belt, which runs 390 ft. per minute.” Tramp metal removed by the Eriez SE magnet is discharged into a hopper installed on a concrete pad.
